SIZING RIPRAP FOR THE PROTECTION OF APPROACH EMBANKMENTS & SPUR DIKES AND LIMITING THE DEPTH OF SCOUR AT BRIDGE PIERS & ABUTMENTS

Volume I: Literature Review & Arizona Case Histories

Prepared by:
Simons, LI & Associates, Inc.
4600 South Mill Avenue, Suite 280
Tempe, Arizona 85282

June 1989

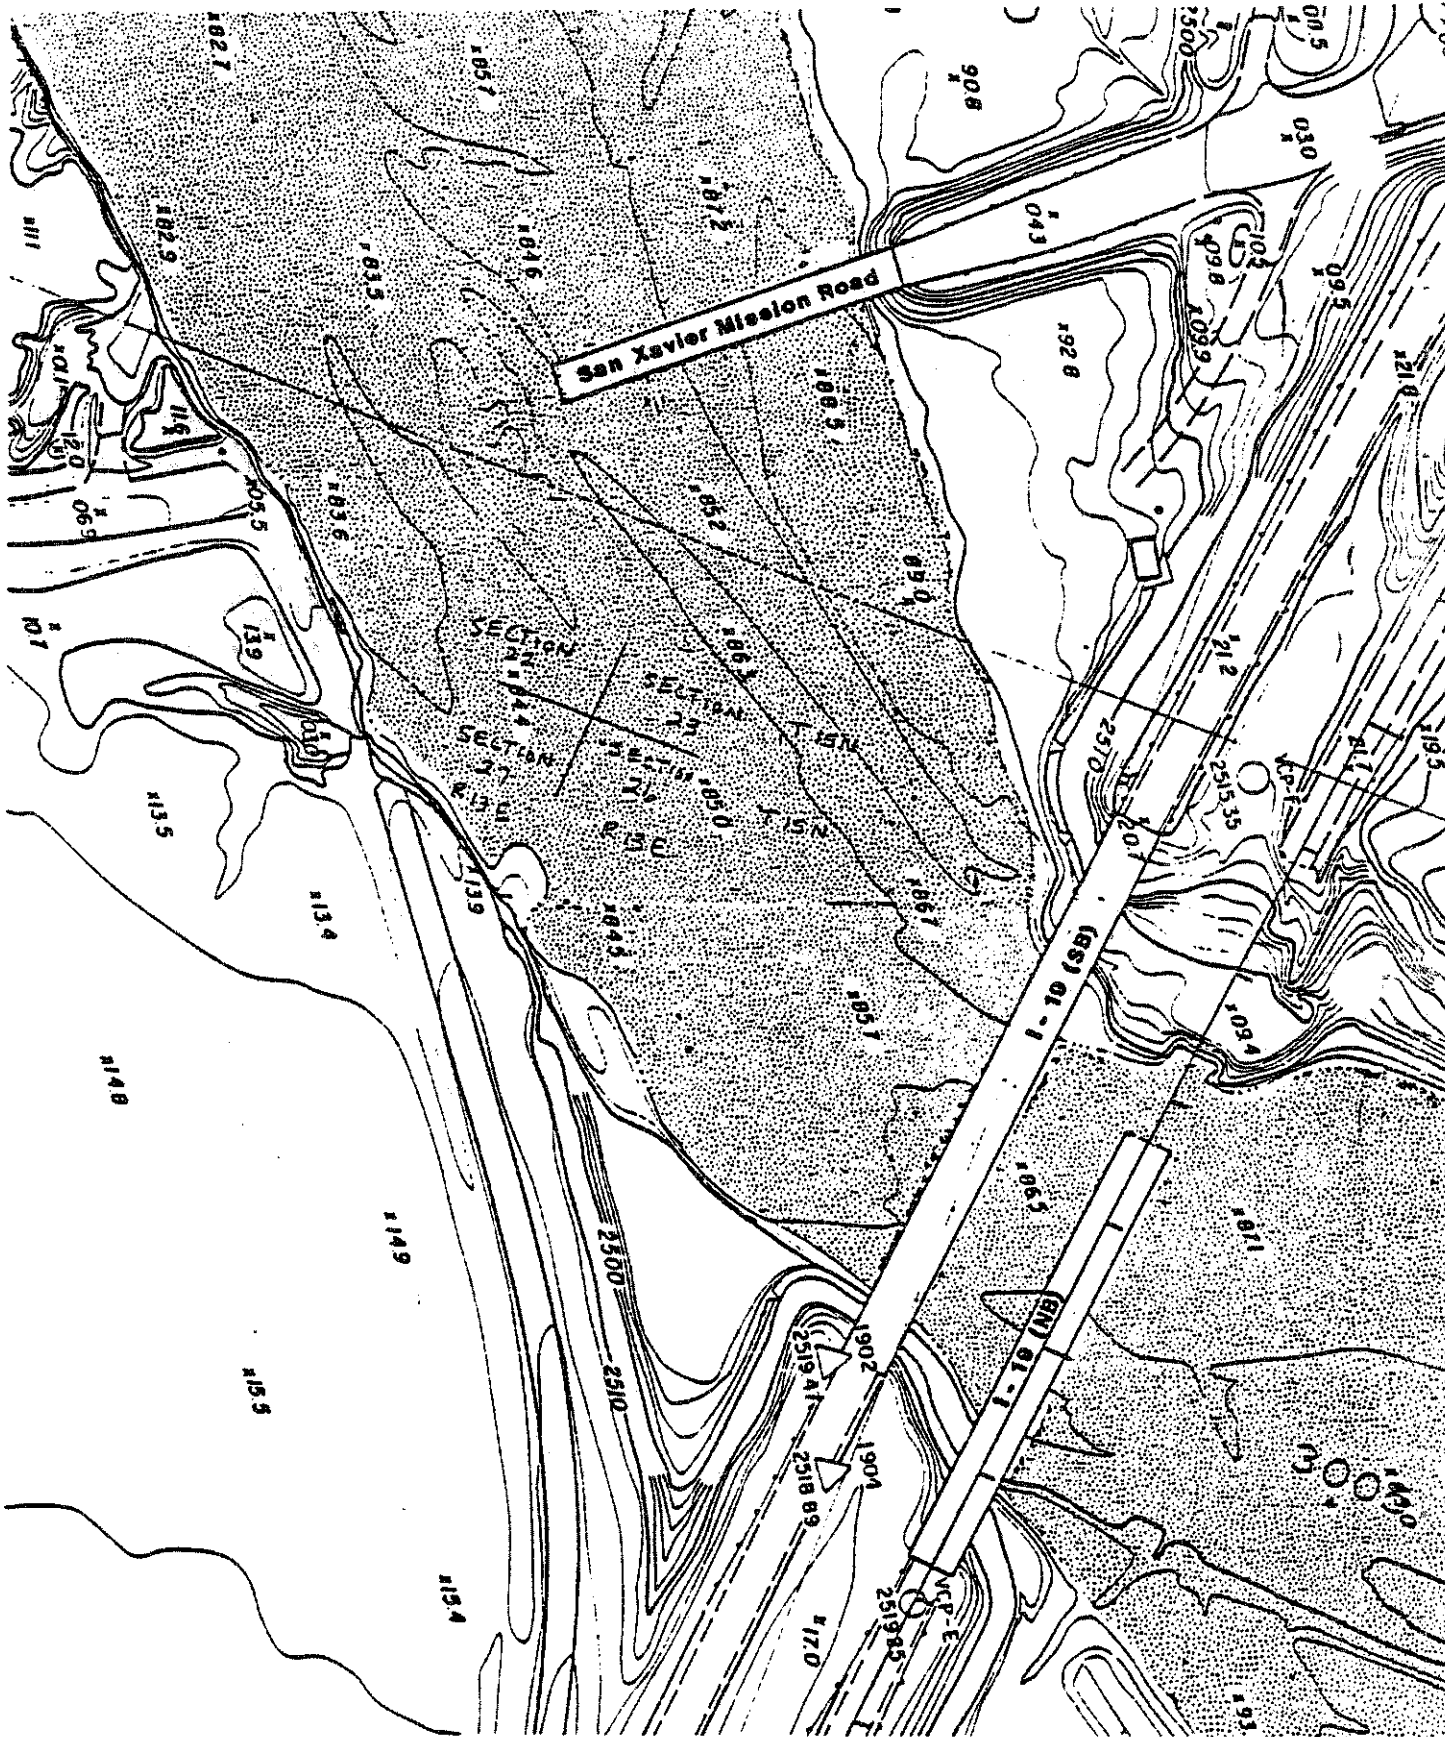
Figure 6. Santa Cruz River topography at I-19 bridge after October 1983 flood. Scale 1"=133' (ADCT Hydraulics Group)

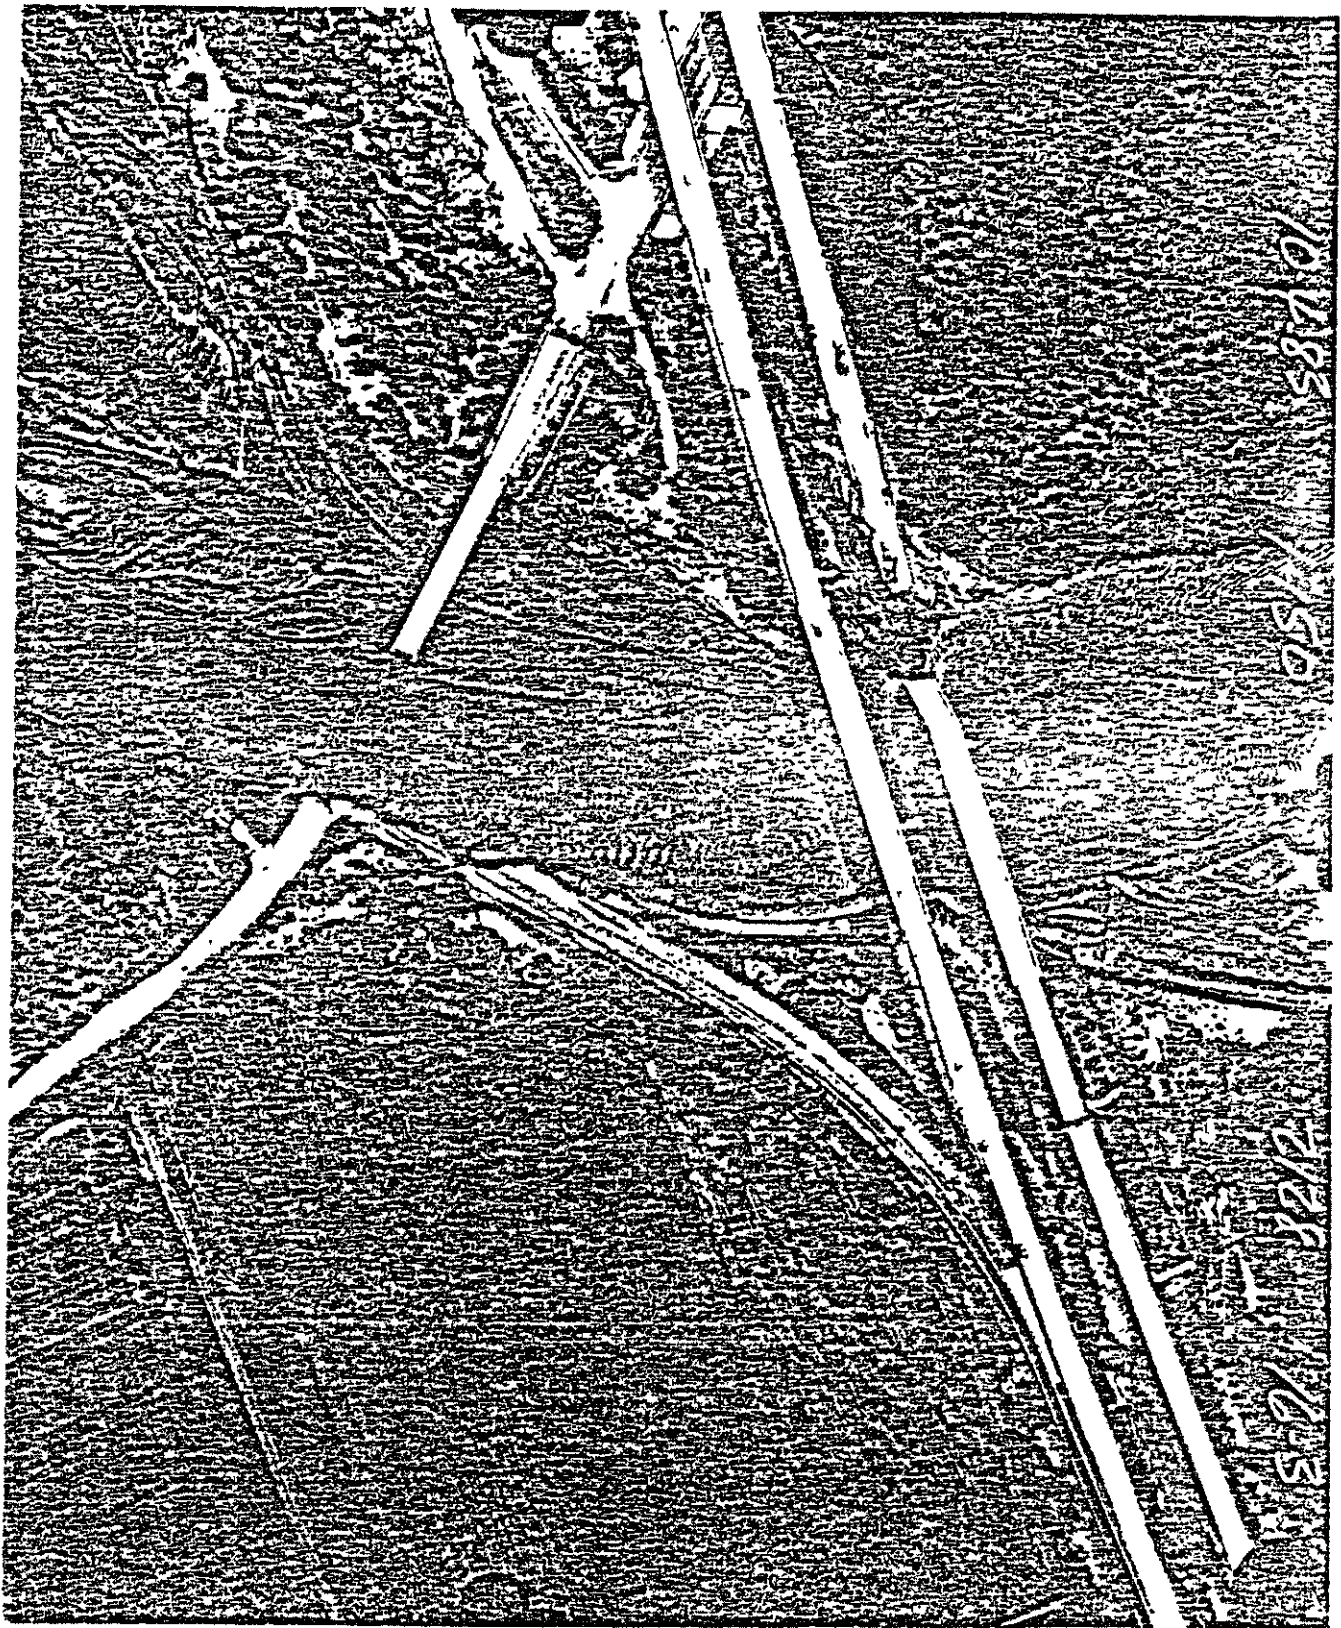
Figure 7. Aerial photograph of Santa Cruz River at I-19 bridge after October 1983 flood. (ADOT Photogrammetry Section)

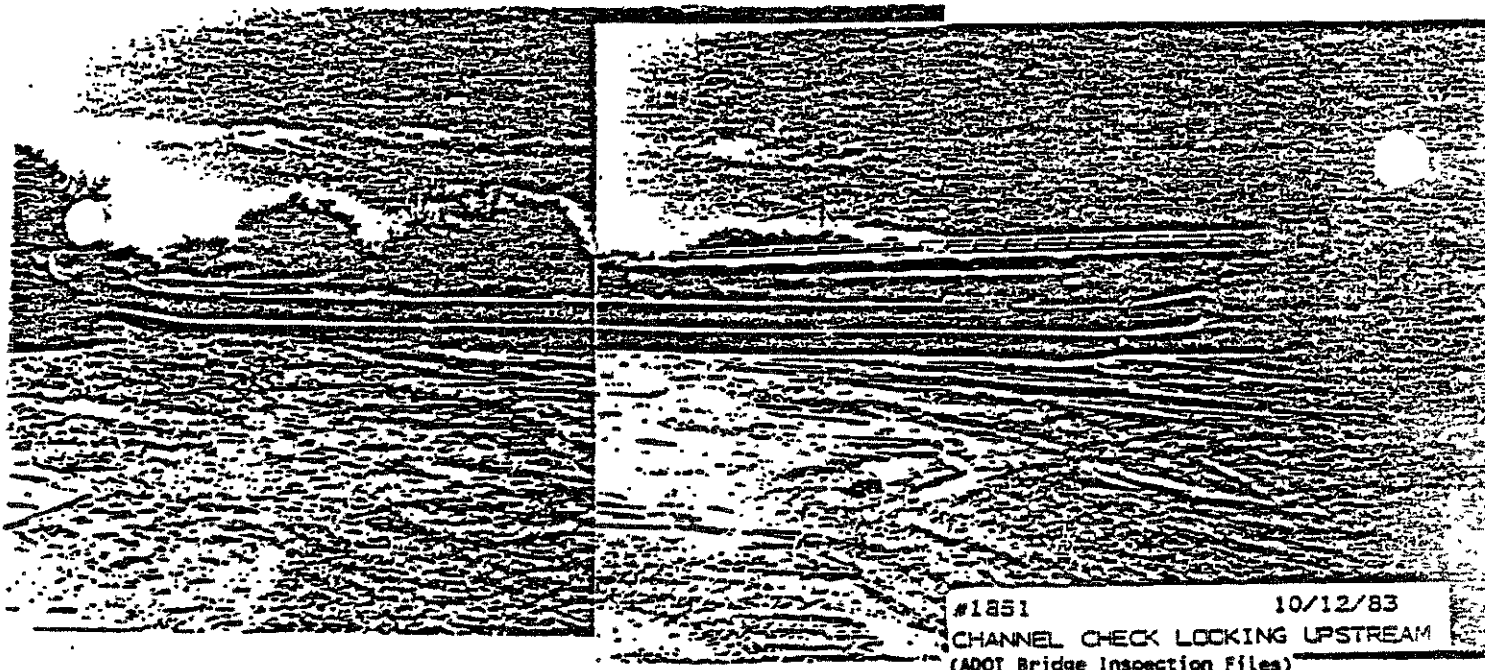
#1851 10/12/83
CHANNEL CHECK LOCKING UPSTREAM
(ADOT Bridge Inspection Files)

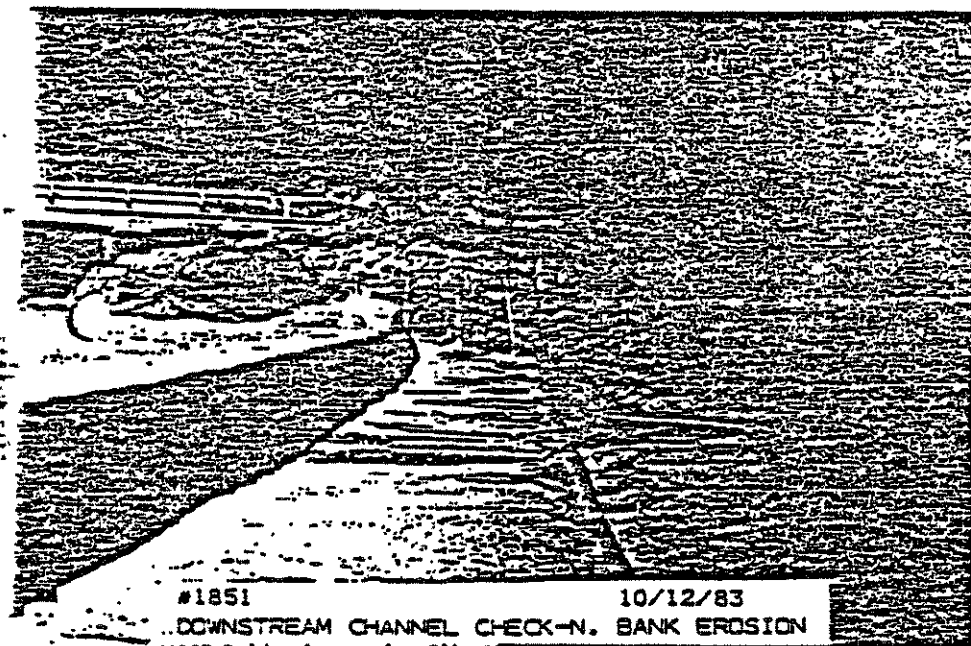
#1851 10/12/83
DOWNSTREAM CHANNEL CHECK-N. BANK EROSION
(ADOT Bridge Inspection Files)
